QUALITY CRITERIA FOR INSULATING GLASS UNITS

Conduct visual assessment according to EN1279:2018

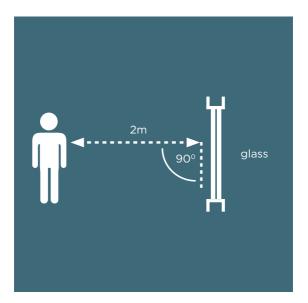
Look at the glass vertically at the right angle (90°) - this concerns the surface of the glass seen from inside the room. Stand 2 m away from the glass. Carry out the assessment in a natural daylight, but not in direct sunlight. The glass needs to be completely dry. Before inspection defects cannot be marked on the glass.

During the visual inspection you need to be looking through the glass rather than at the glass. If a defect is not visible while looking through the glass from the specified distance, it is considered that the defect is not clearly visible or disturbing to the onlooker.
